Infosheet 2.07

Date: October 2003

Citroen Xantia and XM: potential safety problem

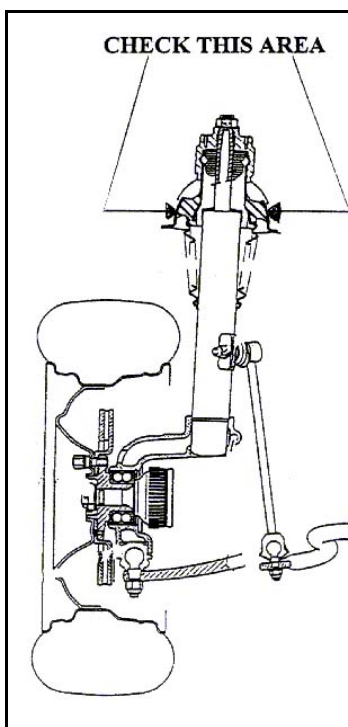
This Infosheet contains advice to vehicle inspectors and inspecting organisations carrying out an inspection of a Citroen Xantia or Citroen XM. There have been failures in the front upper suspension rubber insulating block mounting (oleo-pneumatic suspension leg) of Citroen Models Xantia & XM (see Figures 1 and 2).

Figure 1: Citroen Xantia front suspension indicating rubber insulating block subject to separation of bonding to metal or shearing through of the rubber block.

If presented with a Citroen Xantia or XM vehicle, the vehicle inspector must fail the vehicle if any sign of deterioration or failure of this component is detected during the inspection.

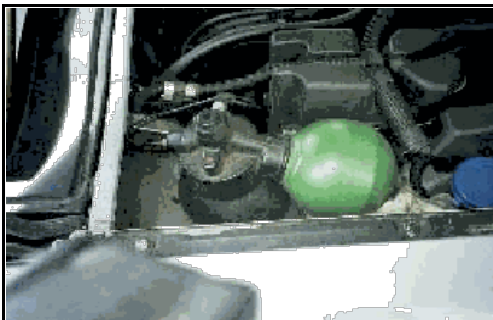
Figure 2: Citroen Xantia upper mounting viewed from under bonnet.

Note that it would be almost impossible to check for deterioration or failure from above, so extra care must be taken to identify deterioration or failure when inspecting the component from underneath the vehicle.

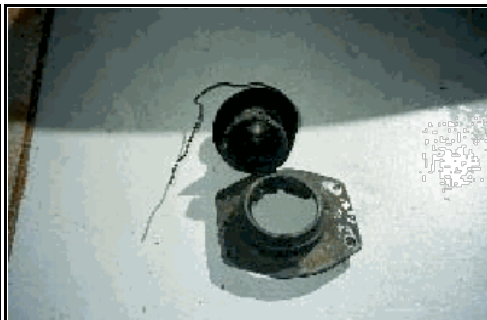
It is believed that allowing the vehicle to operate with low gas pressure in the suspension can contribute to the problem. The failures may be more likely to occur where vehicles have operated in warmer countries before they came to New Zealand

- separation of the rubber bonding to the pressed metal casings
- shear of the rubber block material.

Figure 3: Citroen Xantia rubber mounting in separated (failed) condition.

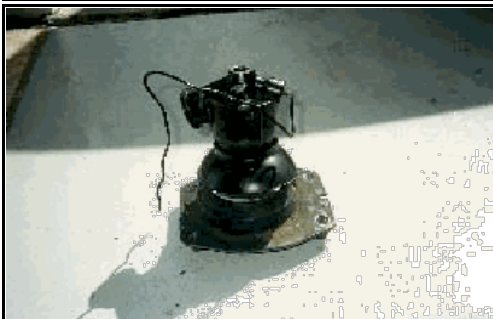
Figure 4: Citroen Xantia rubber mounting assembly in separated (failed) condition.

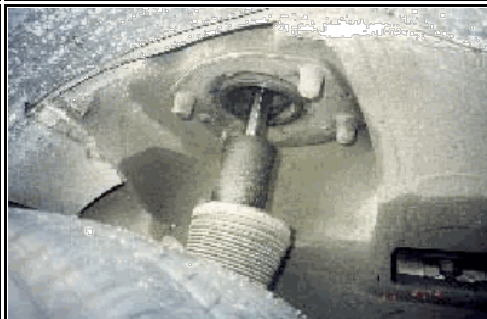
Figure 5: Citroen Xantia upper suspension mounting viewed from underside with protection gaiter removed to allow for better inspection.
